INDOOR AIR QUALITY ASSESSMENT

**Huckleberry Hill Elementary School
5 Knoll Road
Lynnfield, MA 01940**

Prepared by:
Massachusetts Department of Public Health
Center for Environmental Health
Emergency Response/Indoor Air Quality Program
August 2006

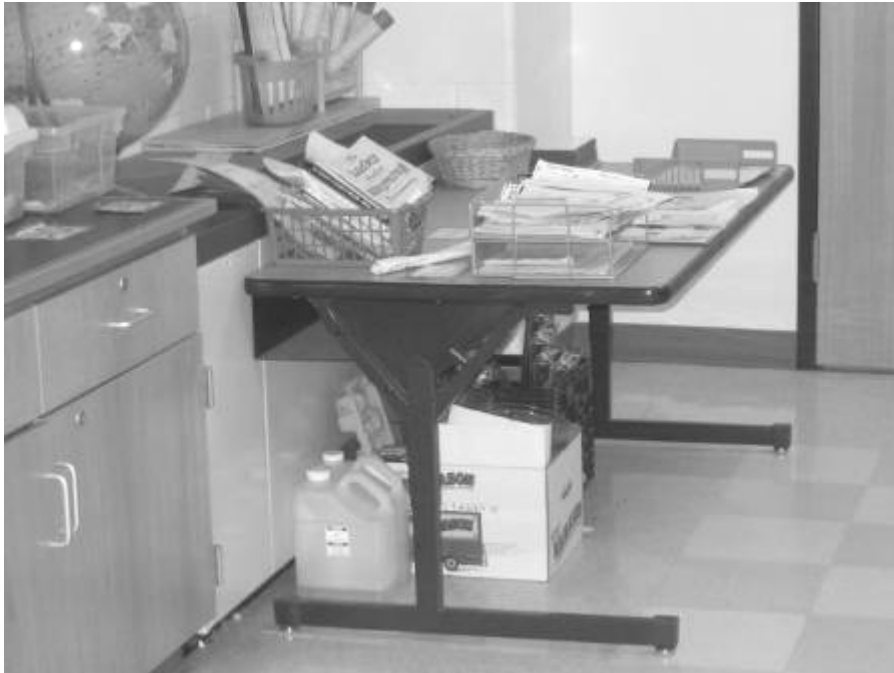
Picture 1

Classroom univent, note materials placed above and in front

4. Remove all blockages from univents and exhaust vents to ensure adequate airflow.
5. Consider adopting a balancing schedule of every 5 years for mechanical ventilation systems, as recommended by ventilation industrial standards (SMACNA, 1994).

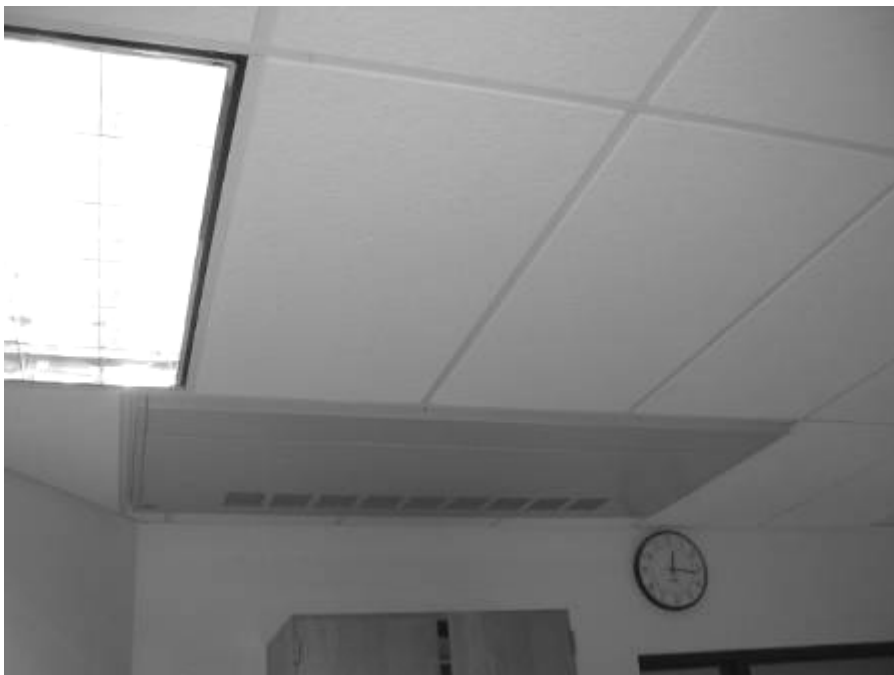
Picture 2

Ceiling-mounted univent

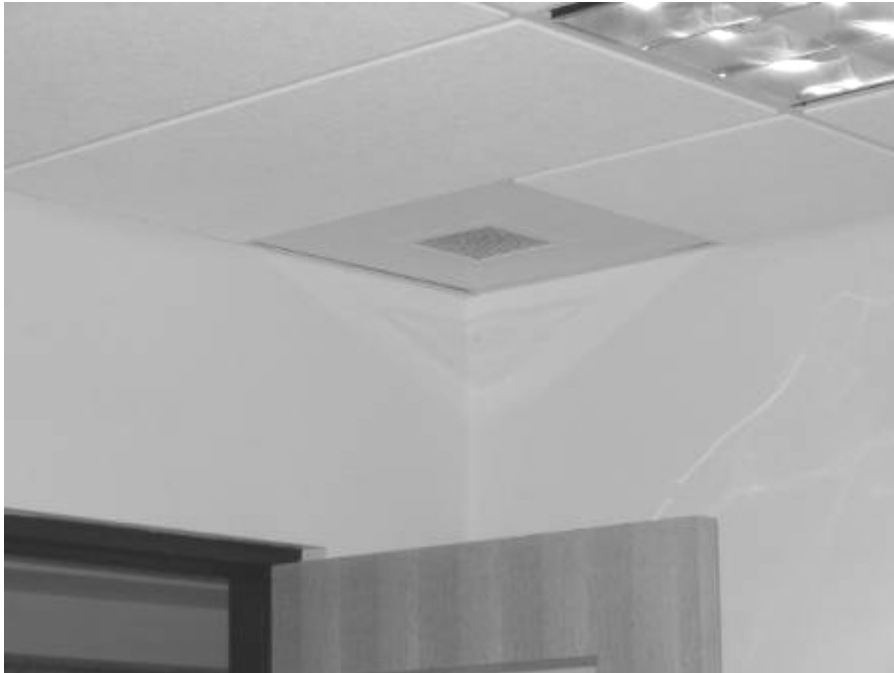
Picture 3

Ceiling-mounted exhaust vent, note proximity to door

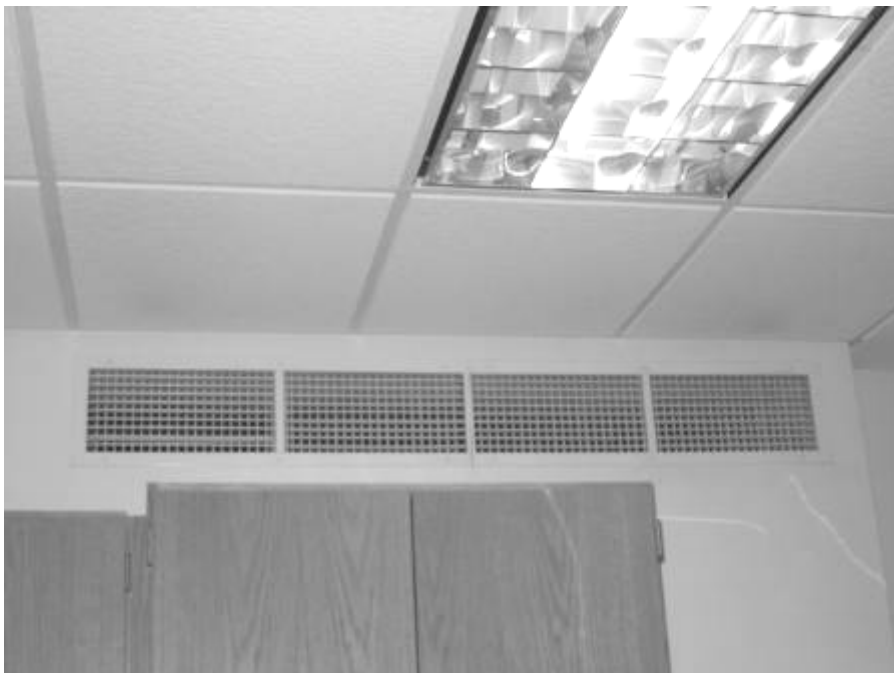
Picture 4

In addition to mechanical ventilation, most rooms at the HHES also have ceiling fans (Picture 4). These ceiling fans help to circulate air within the room, especially during warmer months when windows are open. Ceiling fans were not operating at the time of assessment.

Wall-mounted exhaust vent

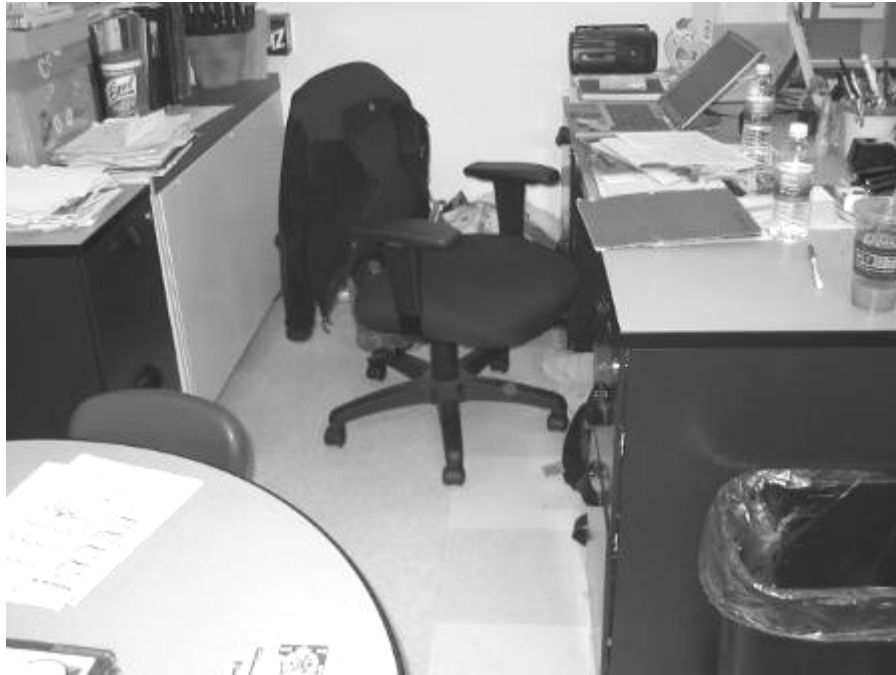
Picture 5

Mechanical exhaust ventilation for classrooms in the 200-series wing is provided by unit exhaust ventilators (Picture 5). A unit exhaust ventilator appears similar to a univent, but removes air from the classroom and exhausts it out of the building. Unit exhaust ventilators appeared to be off or operating weakly in several areas during the assessment. Exhaust vents/ventilators were also obstructed by various items in a number of areas, restricting airflow (Picture 5). As with univents, unit exhausts should be allowed to operate as designed and free of obstructions. Without sufficient supply and exhaust ventilation, normally occurring environmental pollutants can build-up and lead to indoor air quality/comfort complaints.

Unit exhaust, note desk placed in front, limiting airflow

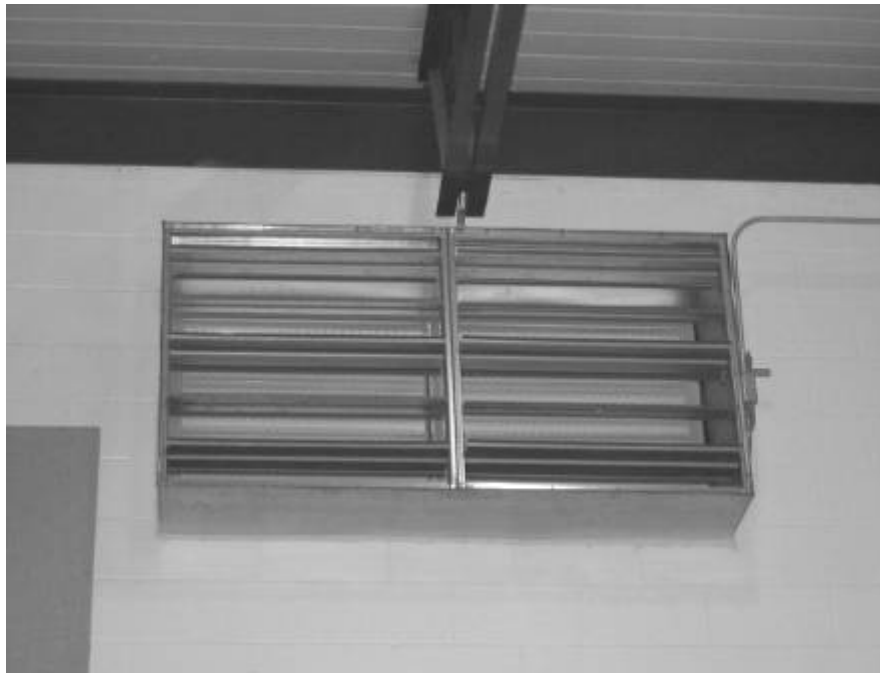
Picture 6

An AHU regulated by a carbon dioxide monitor provides mechanical ventilation to the school's gymnasium. Once a pre-set carbon dioxide reading is exceeded, the AHU and auxiliary fresh air vent (Picture 6) is activated to introduce fresh air. When a second, *lower* pre-set reading is measured by the sensor, the ventilation system is deactivated. Therefore, no mechanical ventilation is provided until the sensor re-activates the system. According to physical education instructors and Mr. Forbes, temperature control issues are often a problem

in the gym, since the auxiliary fresh air vent is often open. To improve occupant comfort, Mr. Forbes or the school custodian must manually override the computerized system. The gymnasium's AHU appeared to be operating at the time of assessment; the auxiliary fresh air vent was not open because of manual override. School officials could not identify the date of last calibration for the carbon dioxide monitor/HVAC controller.

Auxiliary fresh air vent in gymnasium

7. Consider contacting an HVAC engineering firm to have ventilation equipment in the gymnasium balanced and carbon dioxide monitors recalibrated.
8. Use openable windows in conjunction with classroom univents and exhaust vents to increase air exchange. Care should be taken to ensure windows are properly closed at night and weekends to avoid the freezing of pipes and potential flooding.

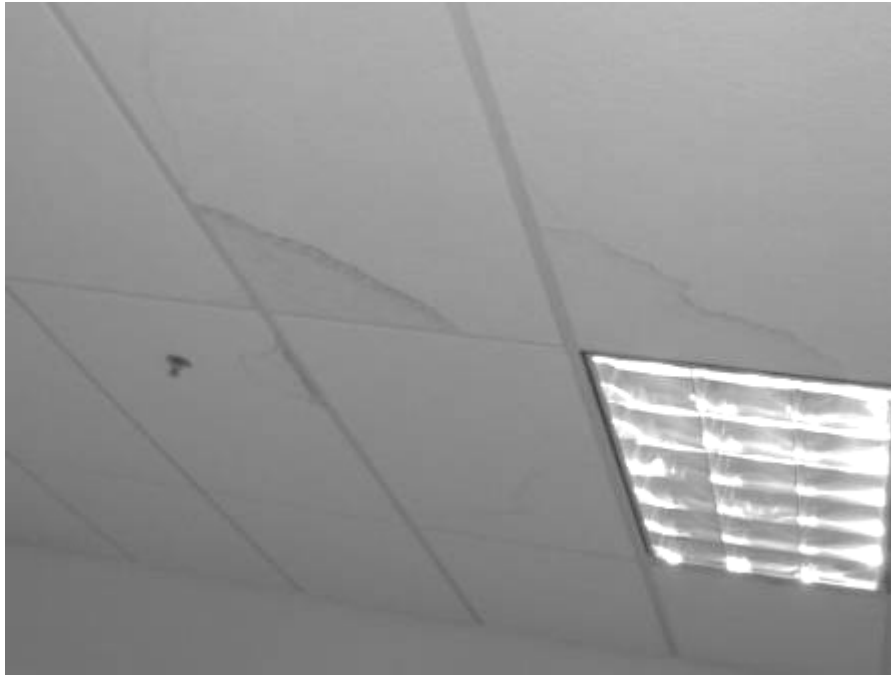
Picture 7

Several areas had water-stained ceiling tiles (Picture 7), which can indicate leaks from the roof or plumbing system. Water-damaged ceiling tiles can serve as a medium for mold and should be replaced after a water leak is discovered and repaired. The American Conference of Governmental Industrial Hygienists (ACGIH) and the US Environmental Protection Agency (US EPA) recommends that porous materials be dried with fans and heating within 24 to 48 hours of becoming wet (ACGIH, 1989; US EPA, 2001). If porous materials are not dried within this time frame, mold growth may occur. Cleaning cannot adequately remove mold growth from water-damaged porous materials. The application of a mildewcide to moldy porous materials (e.g., ceiling tiles) is not recommended.

Water-damaged ceiling tiles

11. Replace water-damaged ceiling tiles once repairs are made. Examine the area above and around water-damaged areas for mold growth. Disinfect areas with an appropriate antimicrobial as needed.

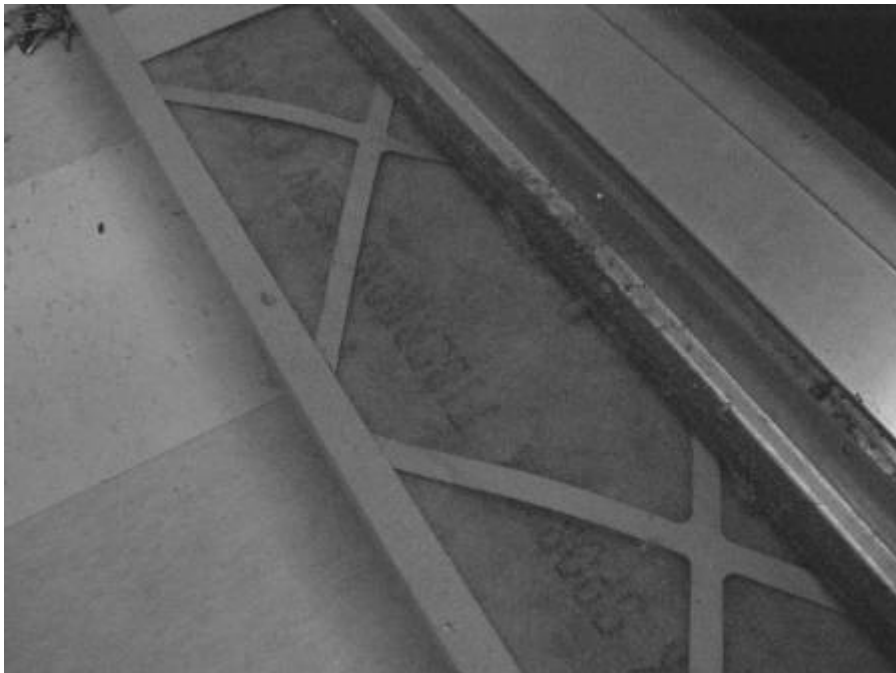
Picture 10

Univents are normally equipped with filters that strain particulates from airflow. Filters used in univents at the HEES provide minimal filtration (Picture 10). In order to decrease aerosolized particulates, disposable filters with an increased dust spot efficiency can be installed. The dust spot efficiency is the ability of a filter to remove particulates of a certain diameter from air passing through the filter. Filters that have been determined by ASHRAE to meet its standard for a dust spot efficiency of a minimum of 40 percent (Minimum Efficiency Reporting Value equal to 9) would be sufficient to reduce many airborne particulates (Thornburg, 2000; MEHRC, 1997; ASHRAE, 1992). Note that increased filtration can reduce airflow produced by increased resistance, a condition known as pressure drop. Prior to any increase of filtration, each univent should be evaluated by a ventilation engineer to ascertain whether they can maintain function with more efficient filters.

Univalent filter

6. Change filters for air-handling equipment as per the manufacturer's instructions or more frequently if needed. Vacuum interior of units prior to activation to prevent the aerosolization of dirt, dust and particulates. Ensure filters fit flush in their racks with no spaces in between allowing bypass of unfiltered air into the unit.
